## Cannop Ponds

### Dam Safety Assessment Report

Reference: 286412-ARP-XX-XX-RP-CX-6102

P3 | 10 January 2023

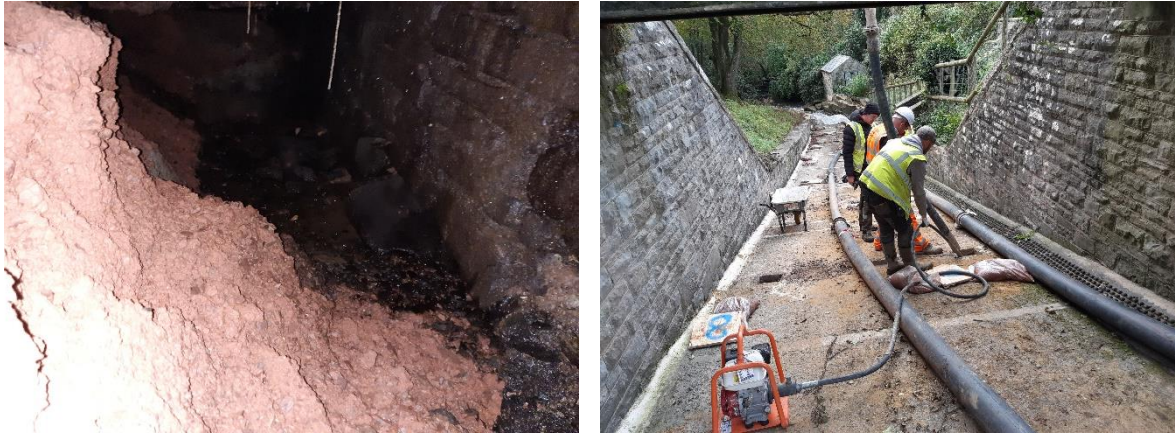
This posed a significant threat to the safety of the dam and emergency works were undertaken. The spillway slab was opened in a number of locations and large volumes of mass concrete were pumped into the voids to provide temporary support and limit further erosion.

**Picture 1 & 2** ©Forestry England - Left - example of voids found beneath spillway. Right - grouting undertaken to make safe in short-term.

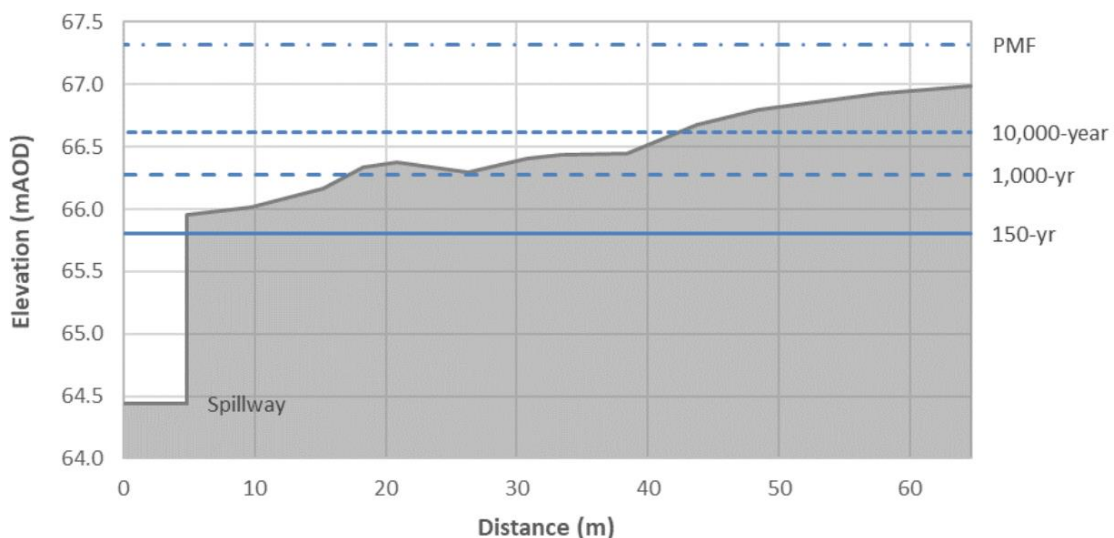
*The flood study has showed that in such an event there would be significant depth of water overflowing both the dam and spillway walls which would cause erosion and potentially lead to breach of the dam embankment.*

*The flood study has shown there is insufficient freeboard to safely protect against wave overtopping, risking a potential breach of the dam embankment.*

**Figure 1 - Lower Cannop Pond Flood Study, Binnies, Jan 2022** - Graphical results of flood rise relative to spillway weir and dam crest level in storm events. Results show insufficient freeboard in 150yr event and overtopping in 1,000yr and over events.

4. The option to replace the spillway with one of sufficient capacity to safely pass these storms is now being investigated. If the spillway was to simply be scaled up, based on the predicted inflows, the weir would need to be roughly three times longer than the existing. The flows would also necessitate the use of reinforced concrete as the main construction material.

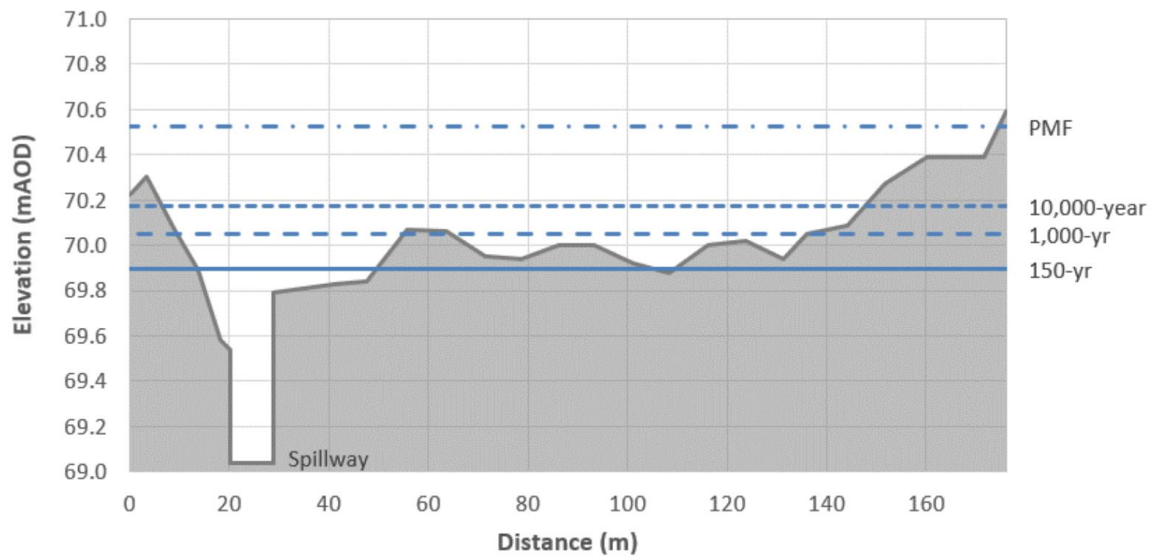
*The flood study has shown there would be overflowing (no freeboard) in storms as likely as 1 in 150yr chance (0.67%) of occurring in any given year.*

**Figure 2** – *Upper Cannop Pond Flood Study, Binnies, Jan 2022* – Graphical results of flood rise relative to spillway weir and dam crest level in storm events. Results show overtopping in 150yr and over events.

These results show the existing spillway is substantially under capacity. A much larger replacement or secondary spillway would therefore likely be need to be designed and constructed. If the spillway was to simply be scaled up, based on the predicted inflows, the weir would need to be roughly four times longer than the existing. The flows would also necessitate the use of reinforced concrete as the main construction material.
