Forestry England

Cannop Ponds

Ground Investigation Report

Reference: 292427-ARP-RE-XX-RP-YY-6155

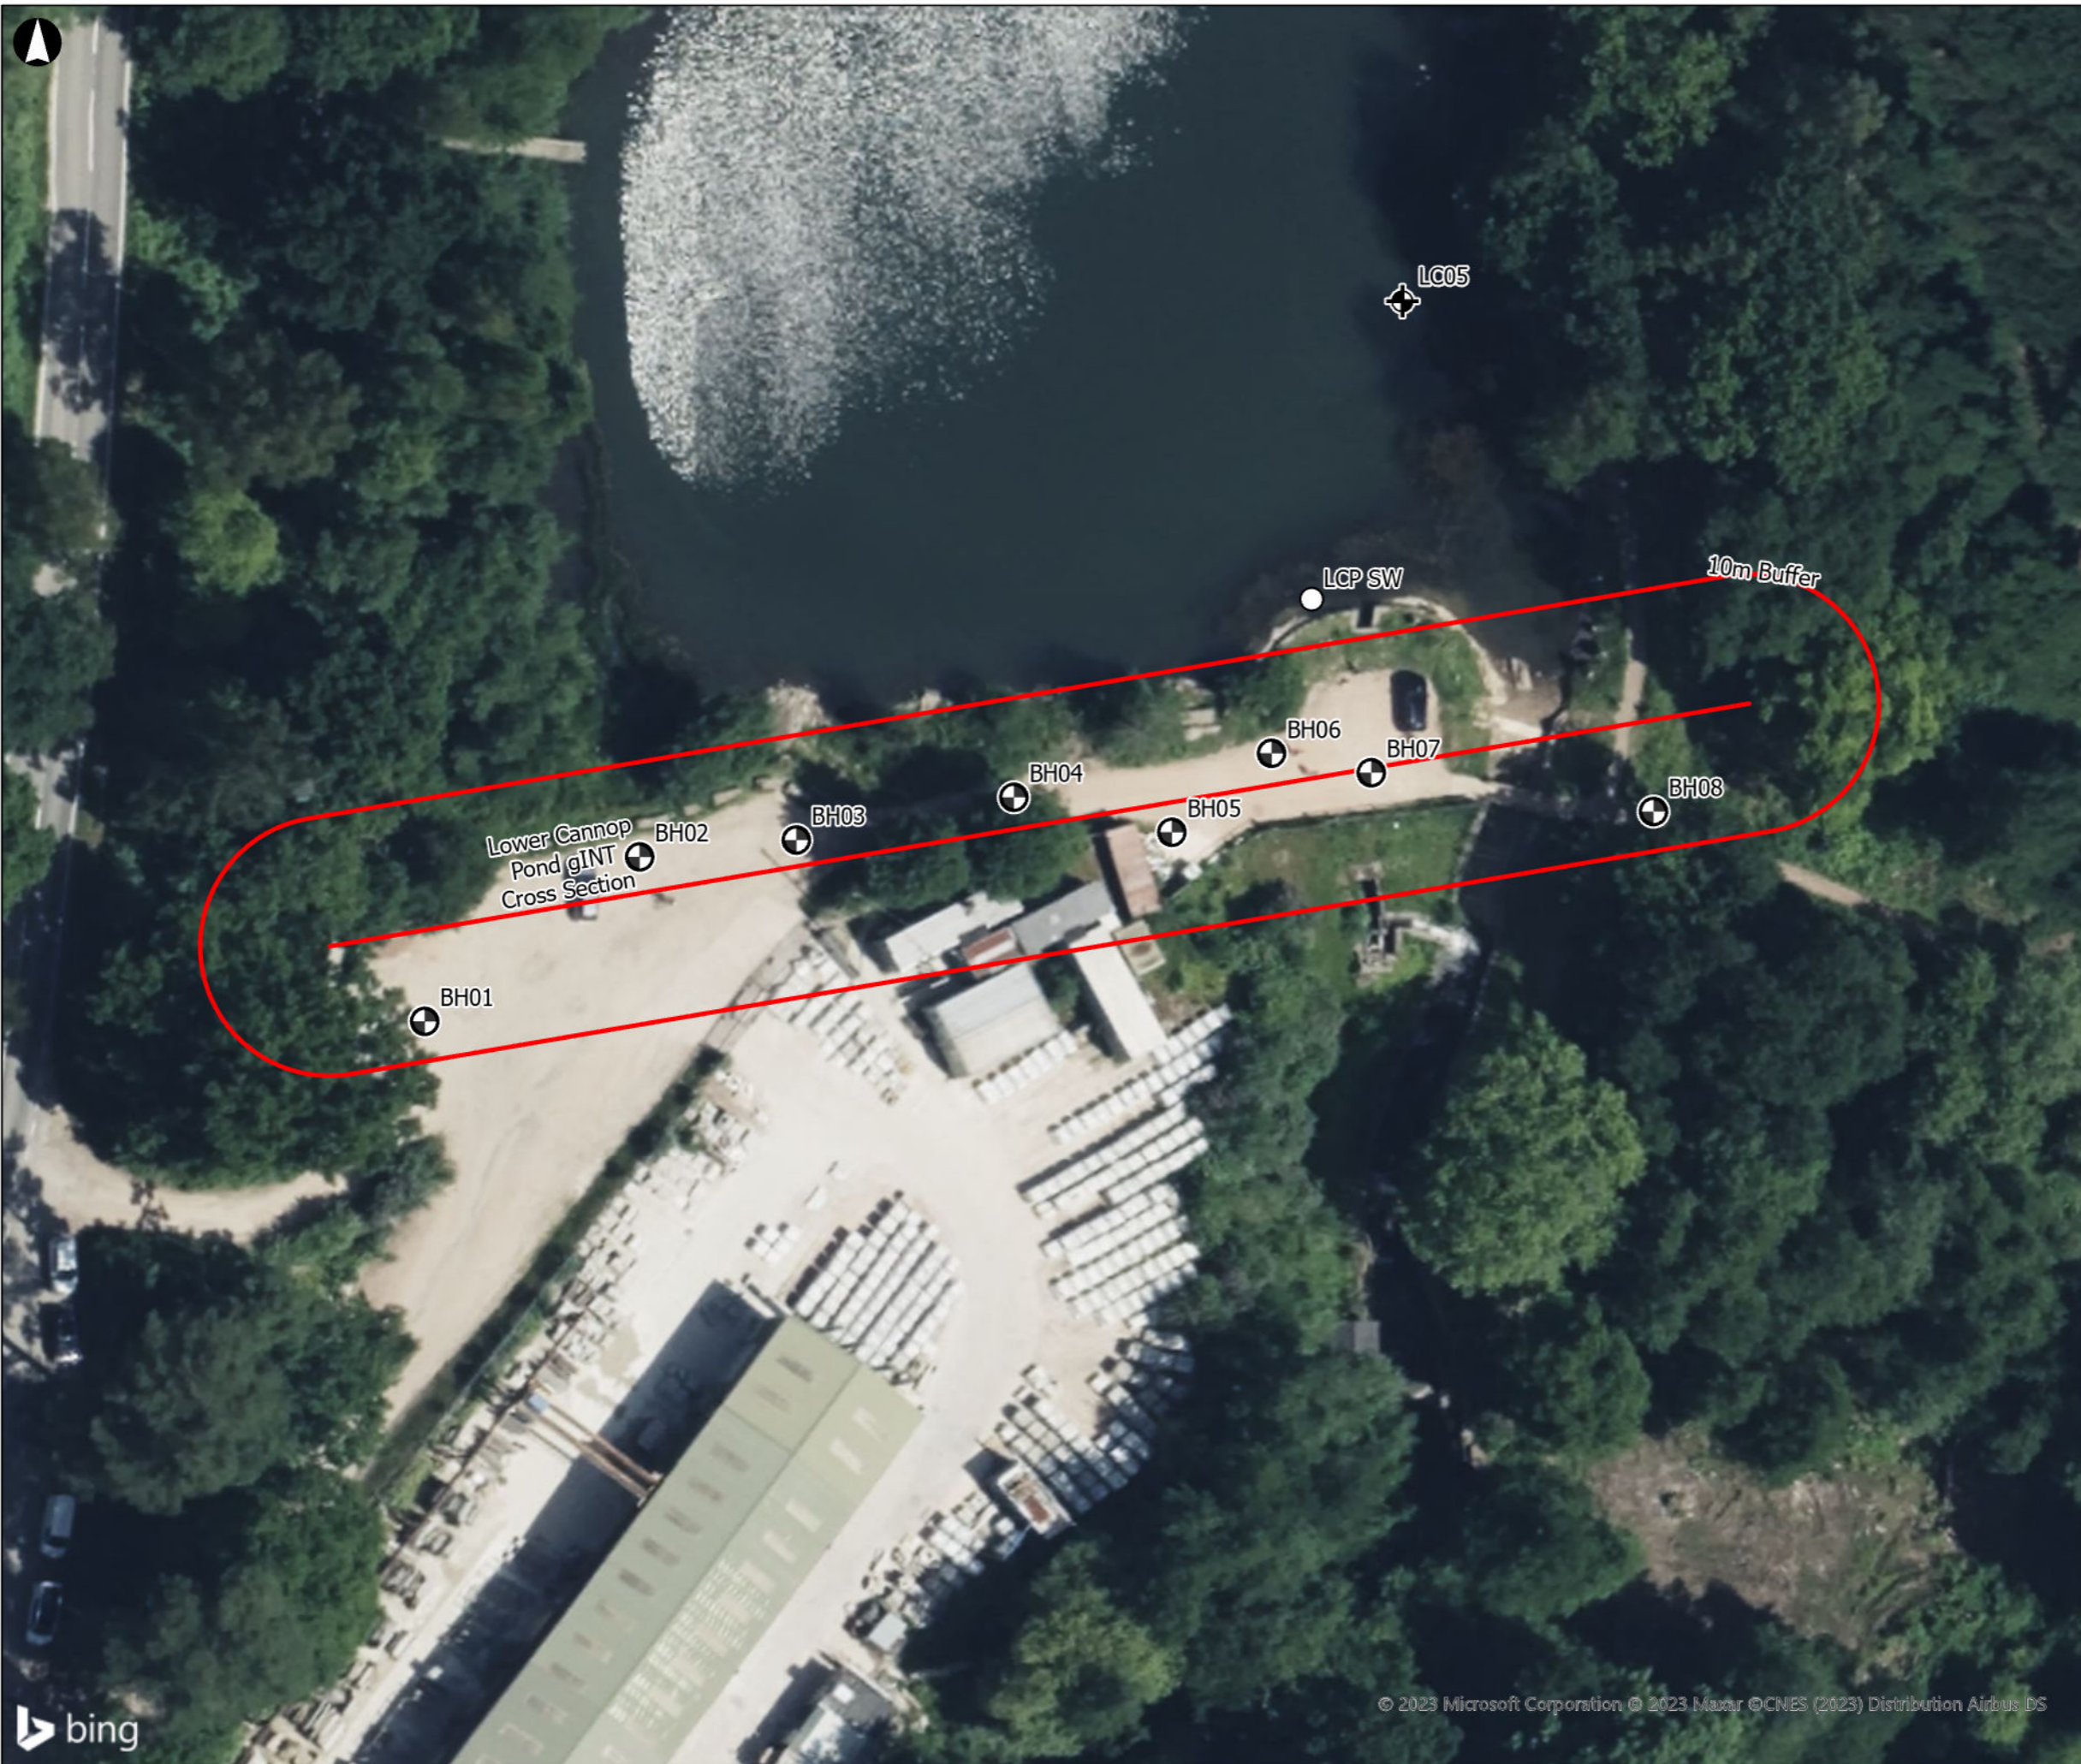
Project Number 286412	Rev 1
Drawing Number 1

Exploratory Hole Locations A3

- BH (DS+RC)
- TP
- WS
- SLSW
- Geological Cross Section

A cross section of the encountered ground conditions is presented in Appendix A Figure 1 (alignment also shown on Drawing 1). The elevation of the dam crest descends from ~68 to ~66mAOD over ~75m west-east linearly. BH08 located to the east of the spillway was situated at ~66mAOD.

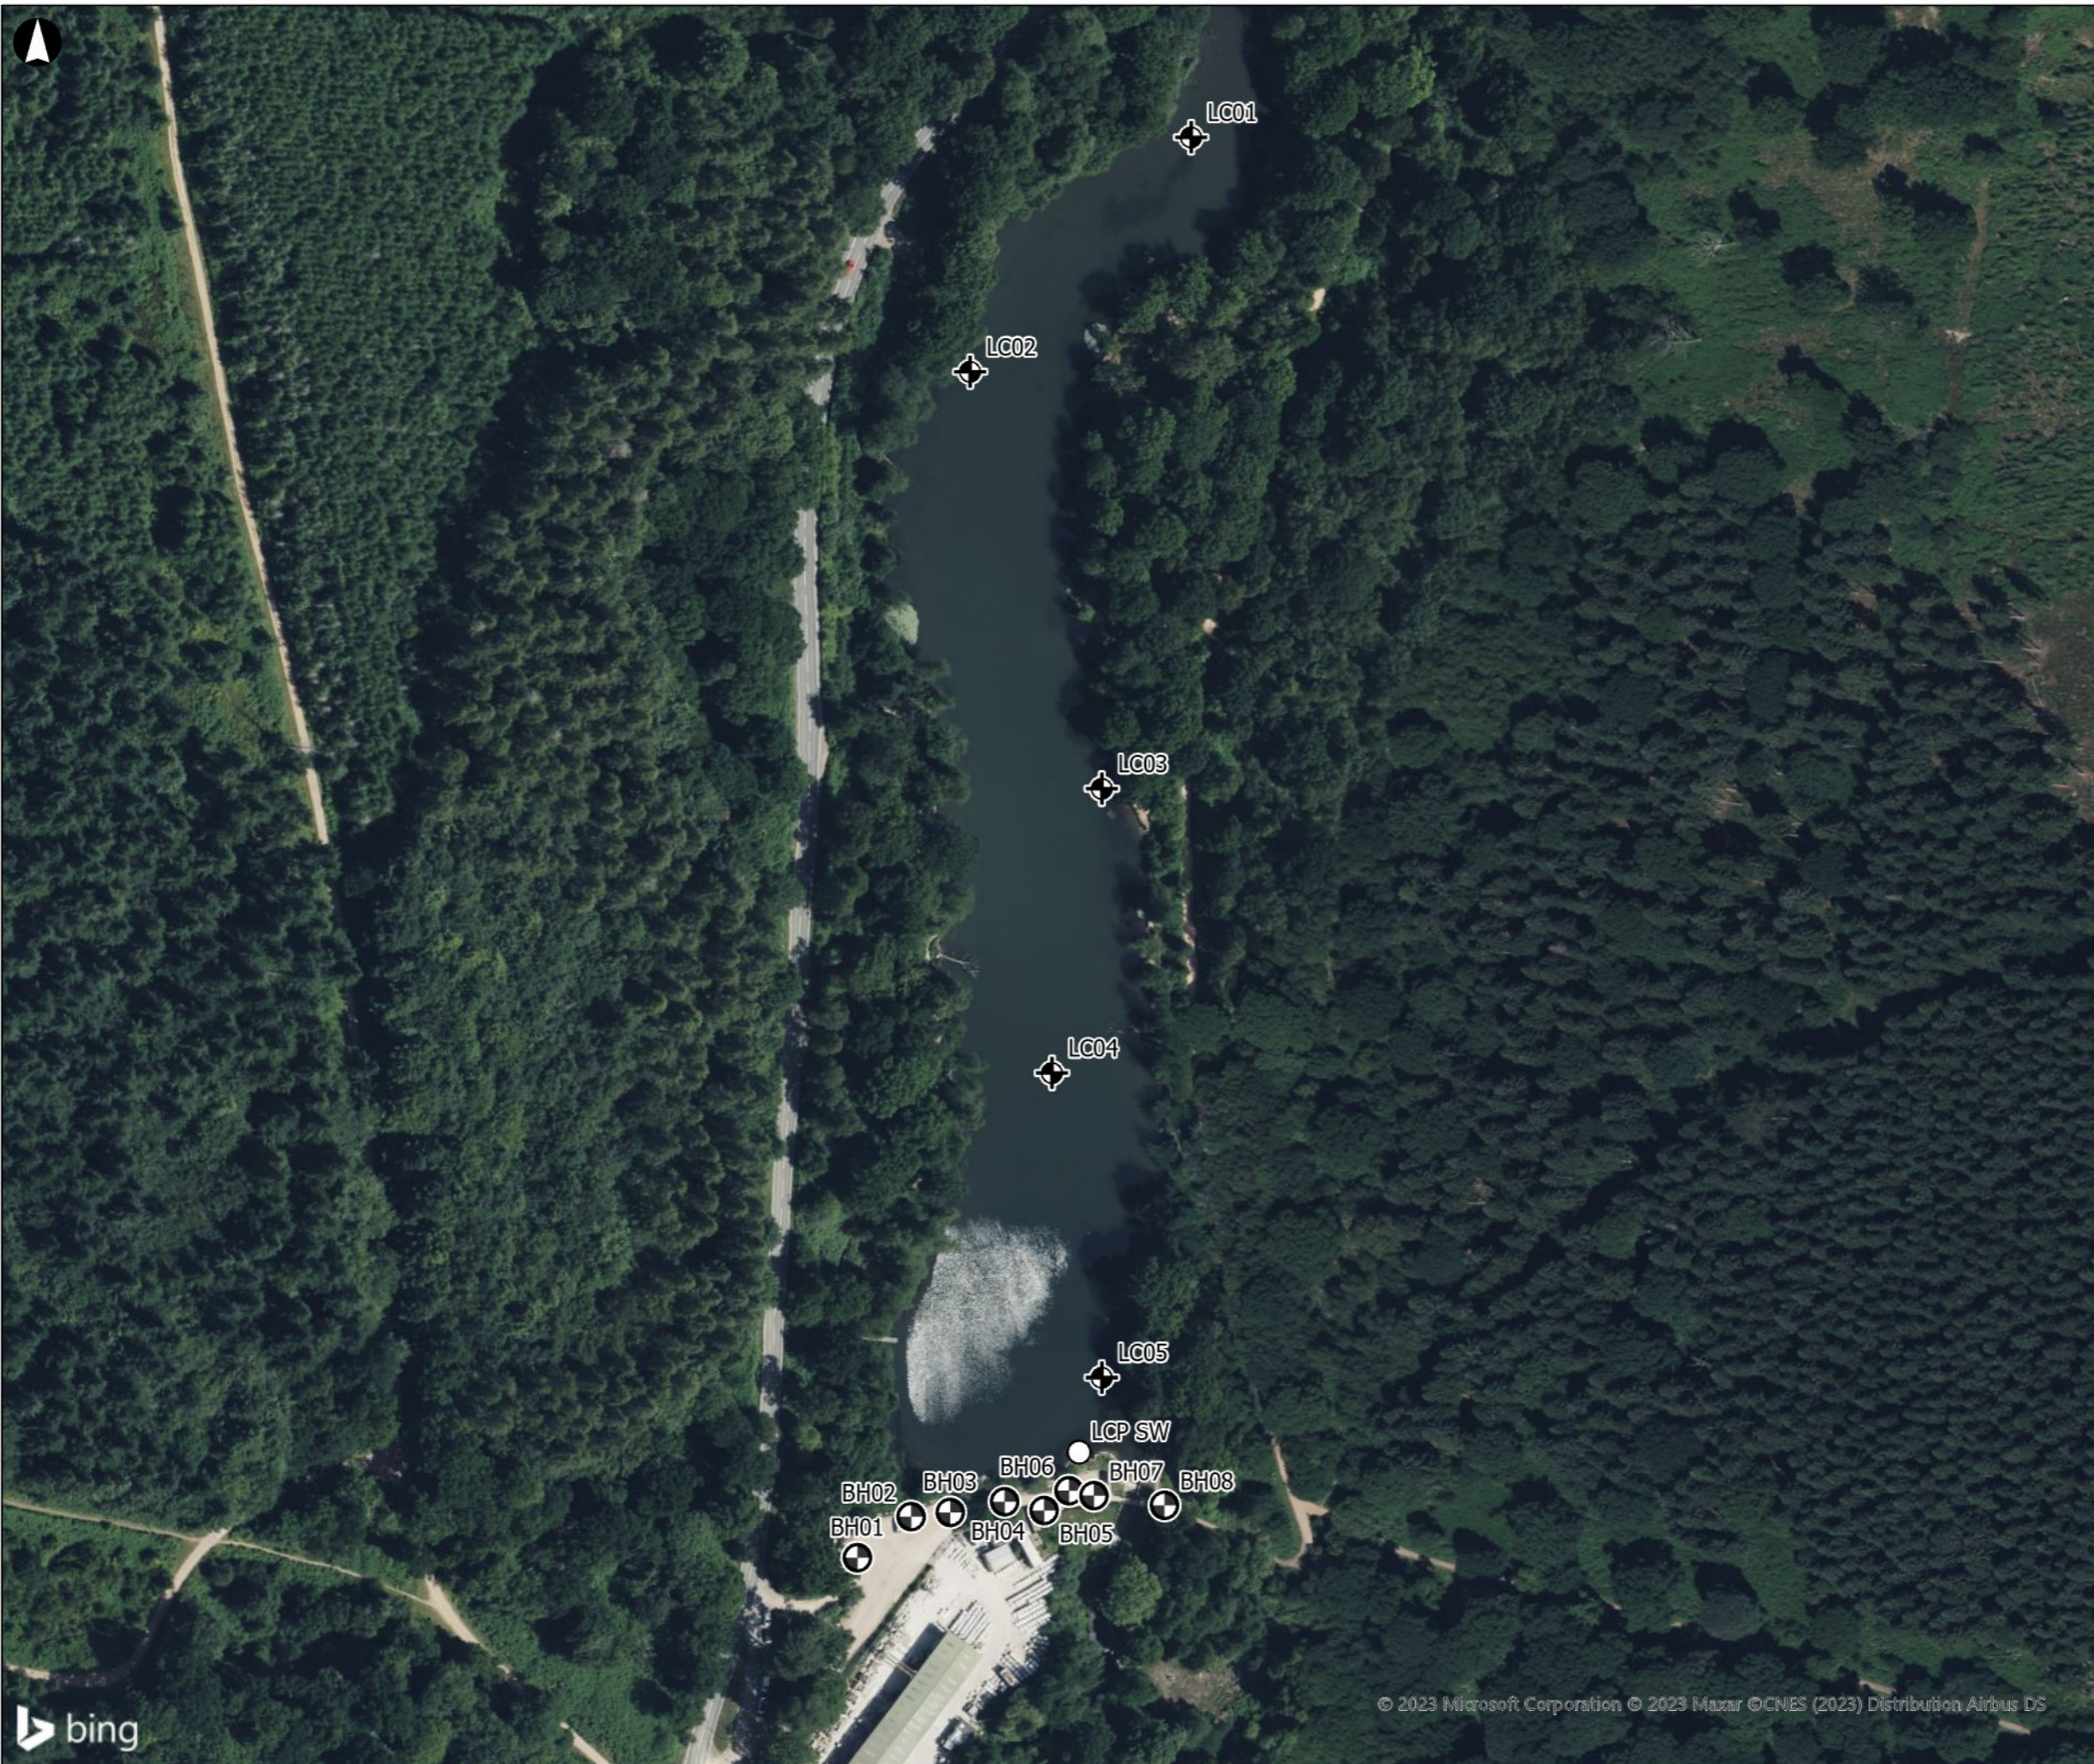
Drawing Number
2

Exploratory Hole Locations

- BH (DS+RC)
- TP
- WS
- SLSW

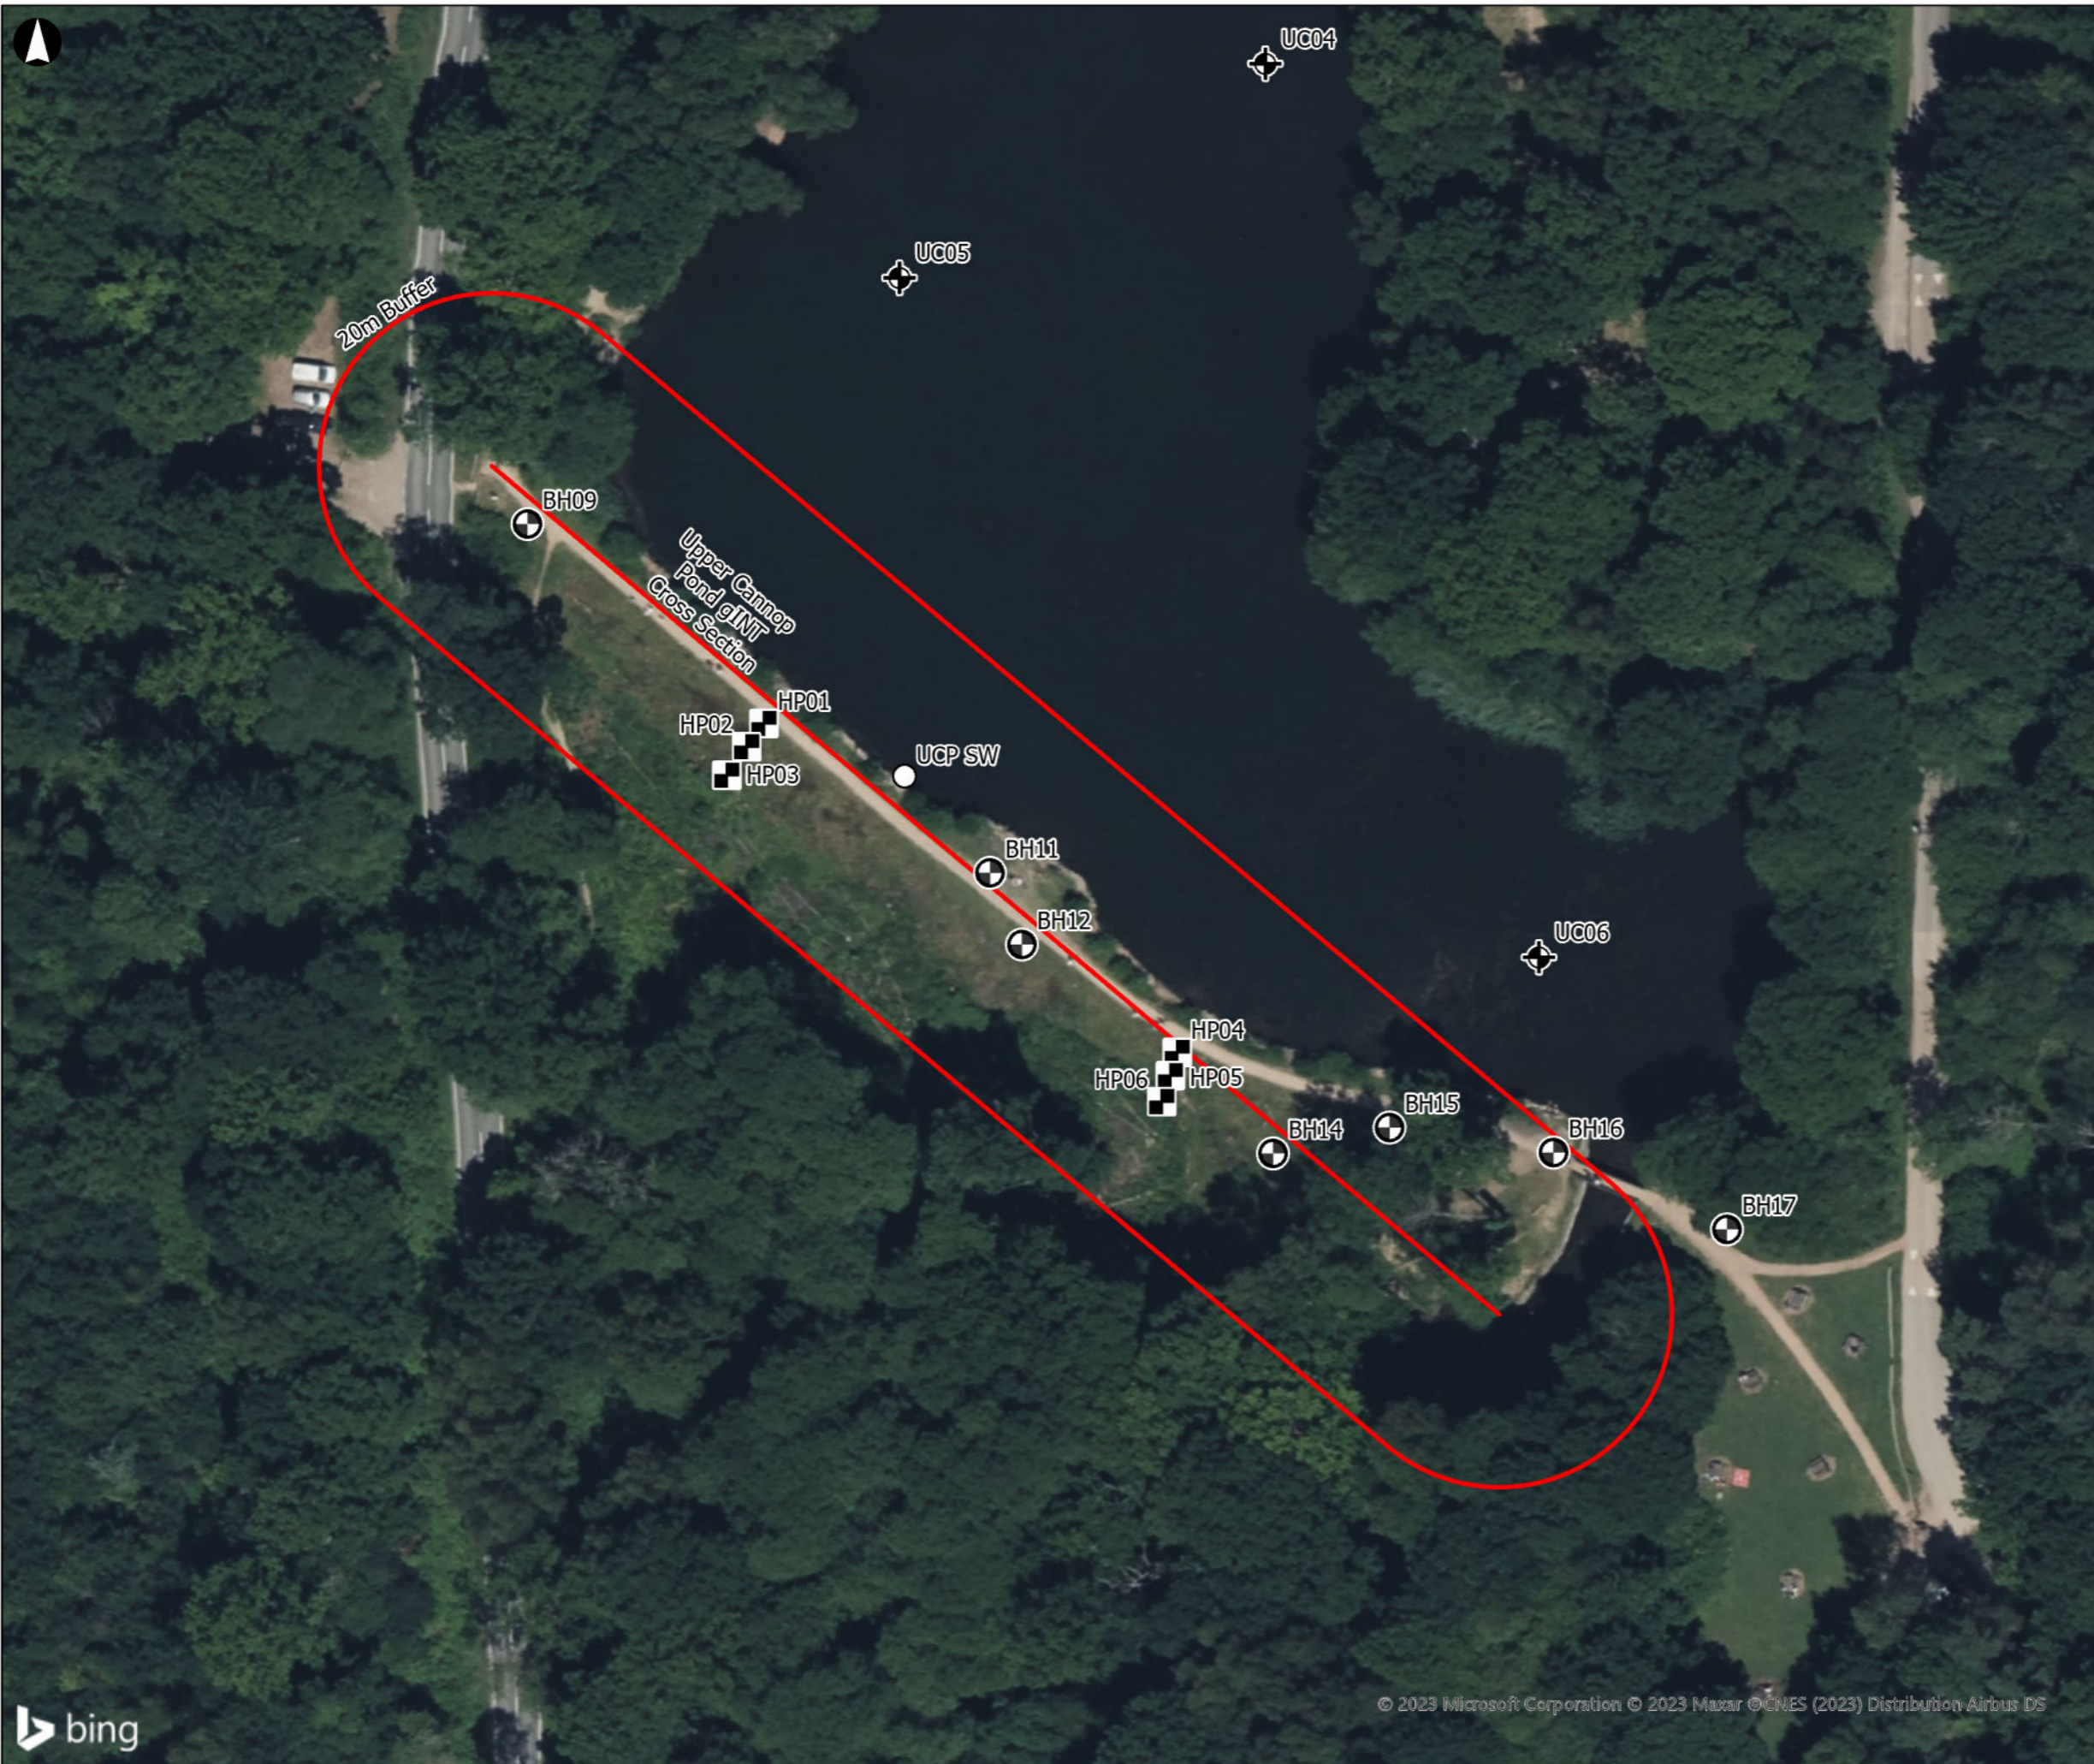
Drawing Number
3

Exploratory Hole Locations

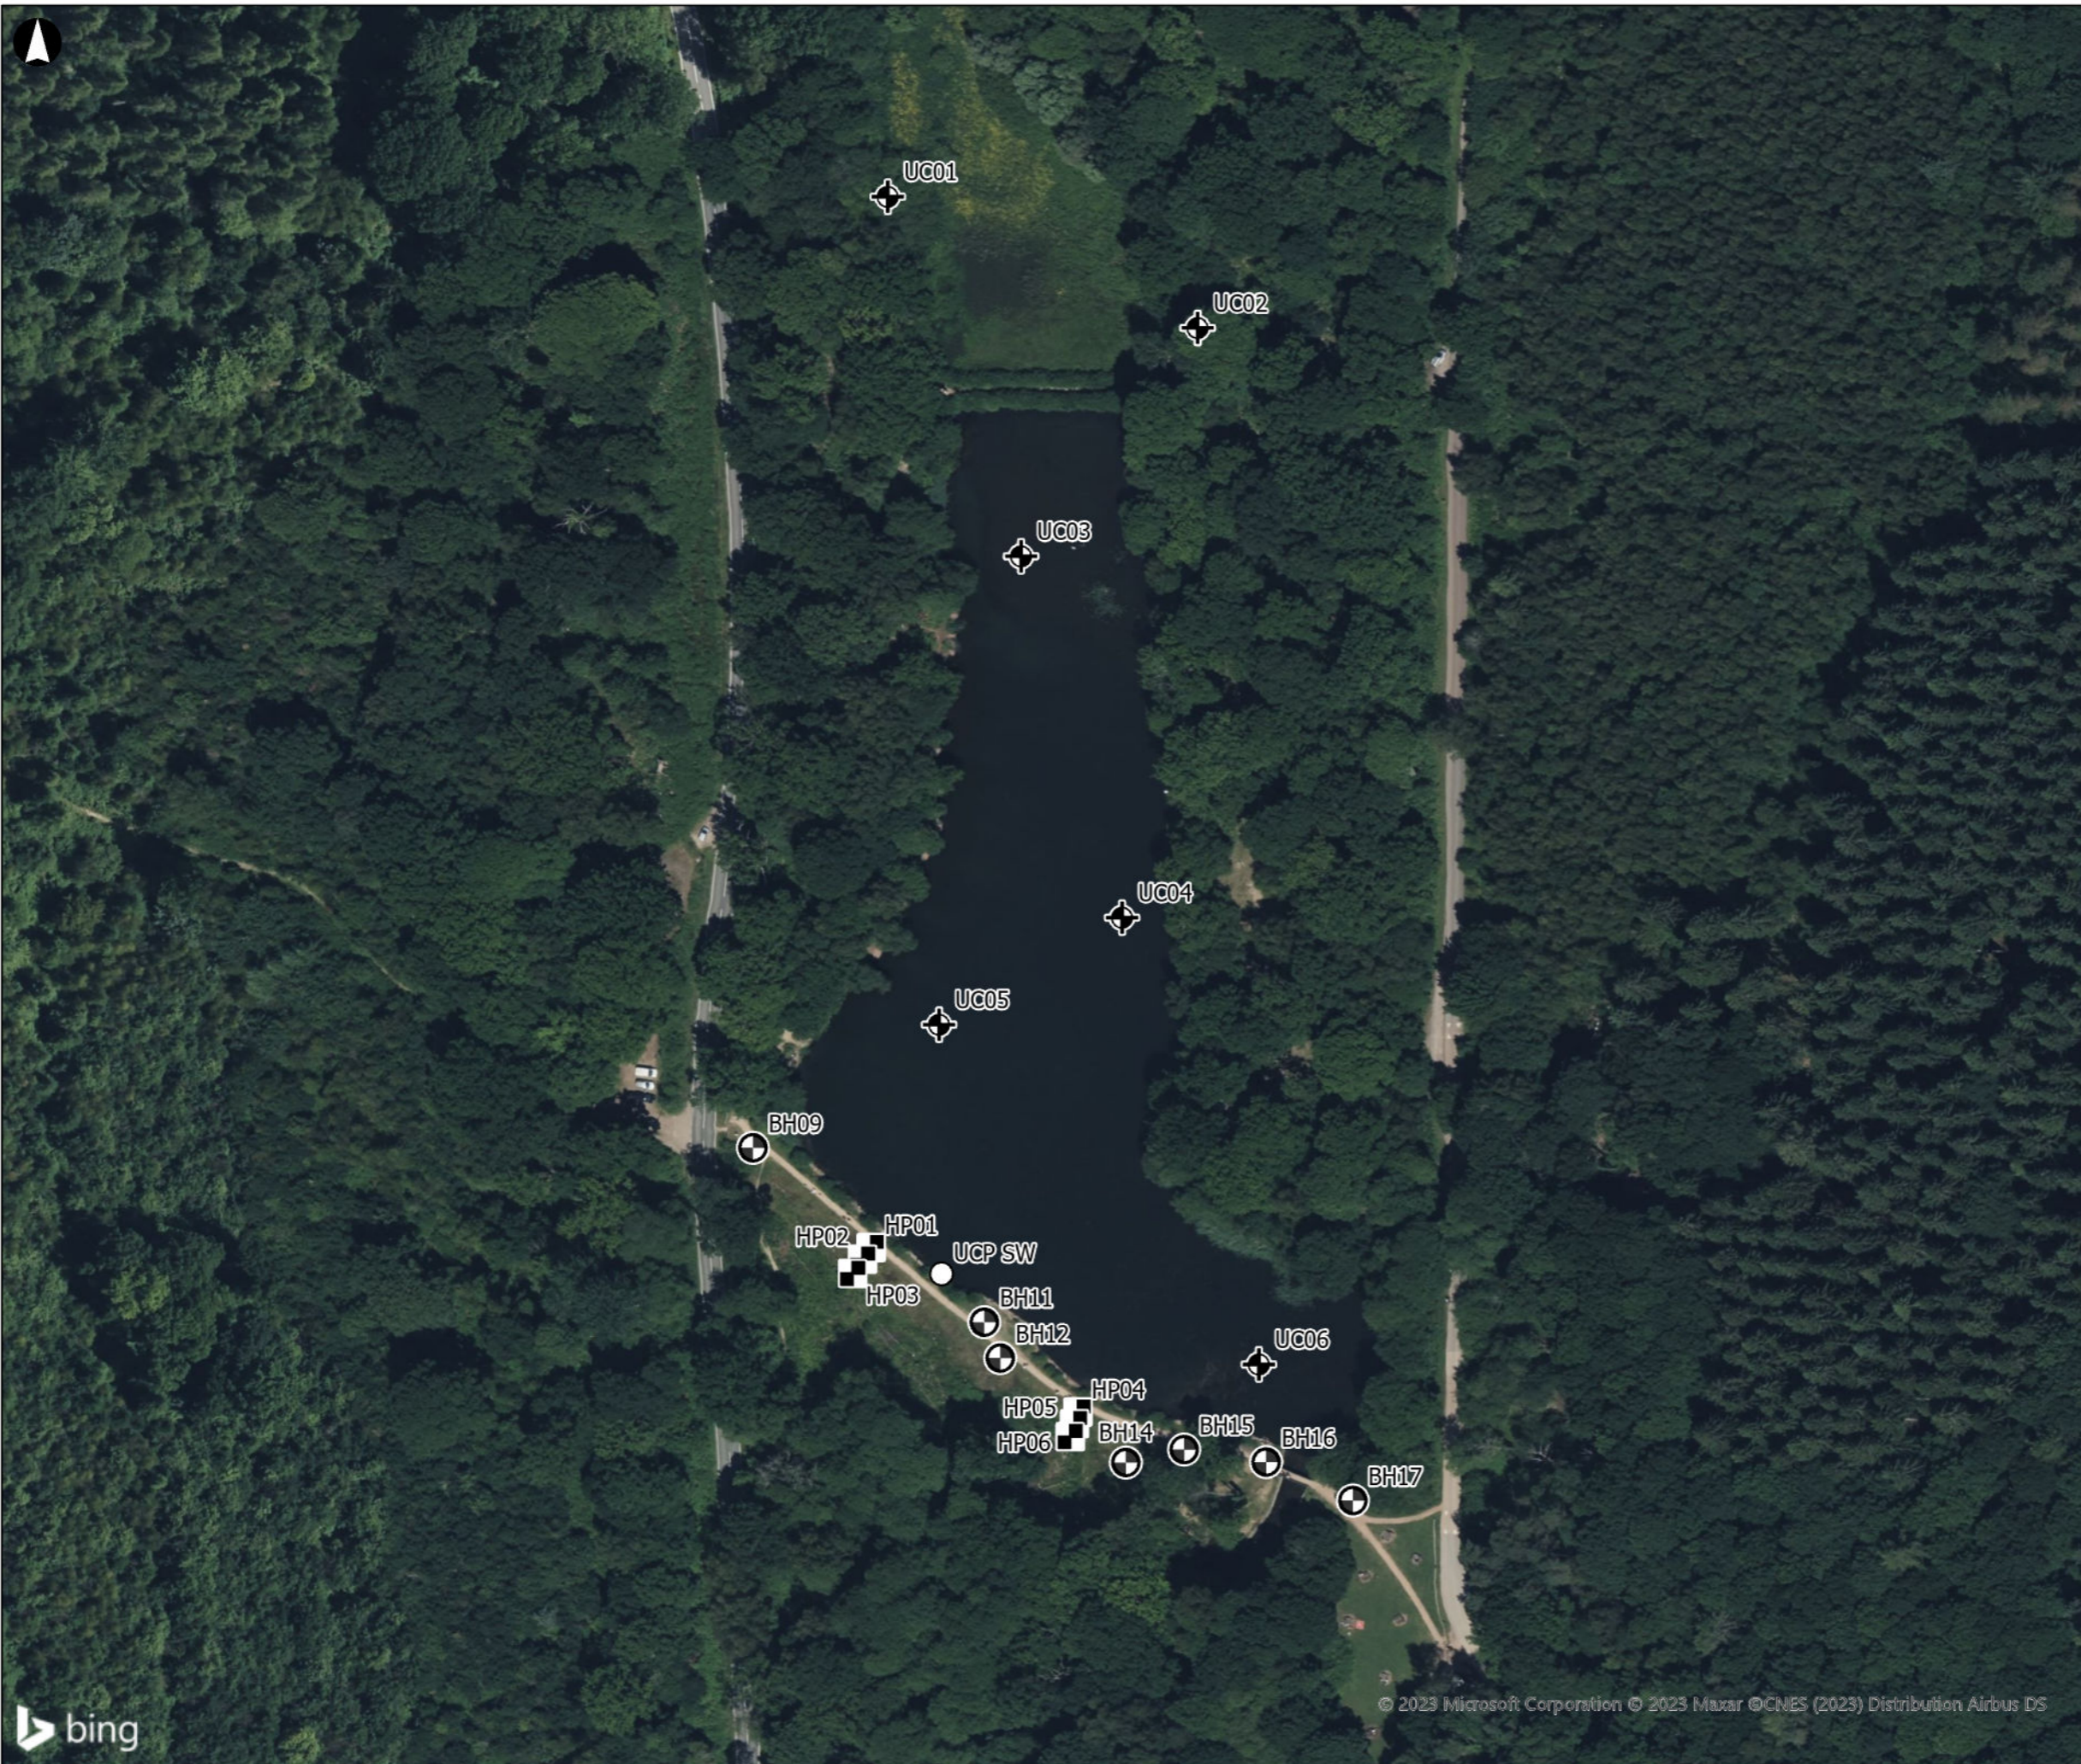
Drawing Number
4

Exploratory Hole Locations

- BH (DS+RC)
- TP
- WS
- SLSW

Drawing 4 – Upper Cannop Pond Exploratory Hole Plan B

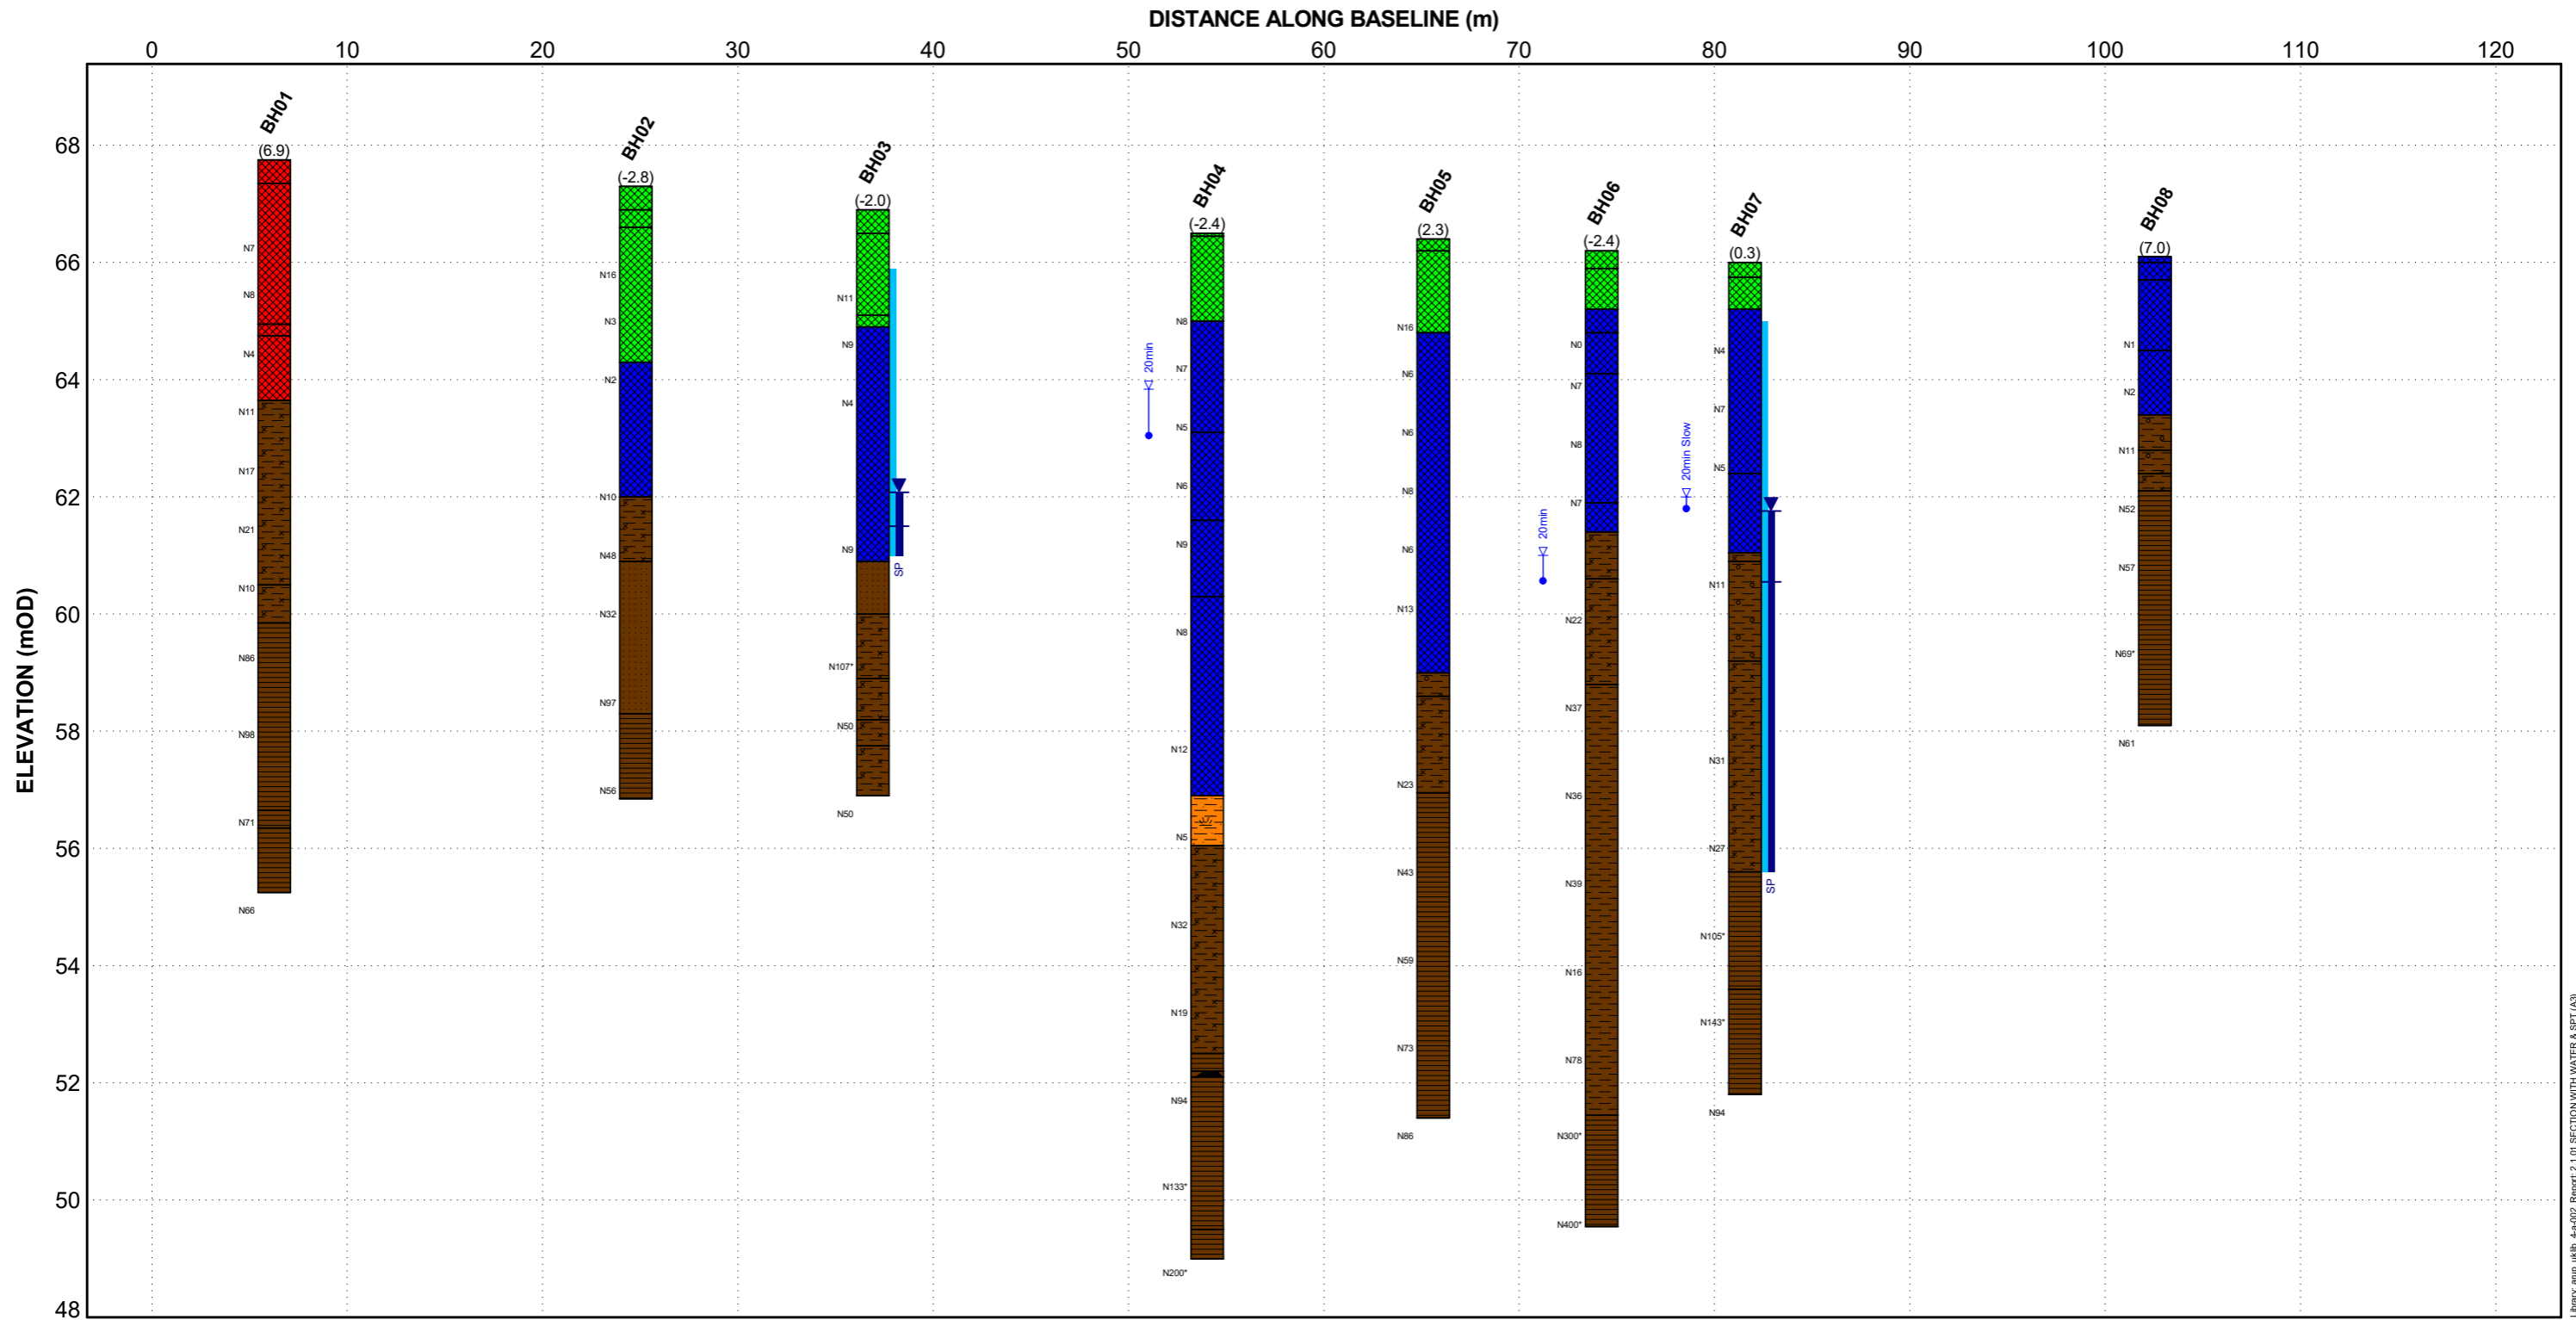
This granular band is underlain by a cohesive layer of Embankment Fill comprising very soft–firm slightly silty sandy gravelly clay. Cohesive Embankment Fill should be considered mixed in composition and not necessarily dominated by cohesive material in all areas. The thickness of this layer varies between ~2m–8m between BH02 and BH07. Cohesive Embankment Fill is also encountered in BH08 to the east of the spillway and was found at surface (~66mAOD) down to ~63.5mAOD (a thickness of ~3m).

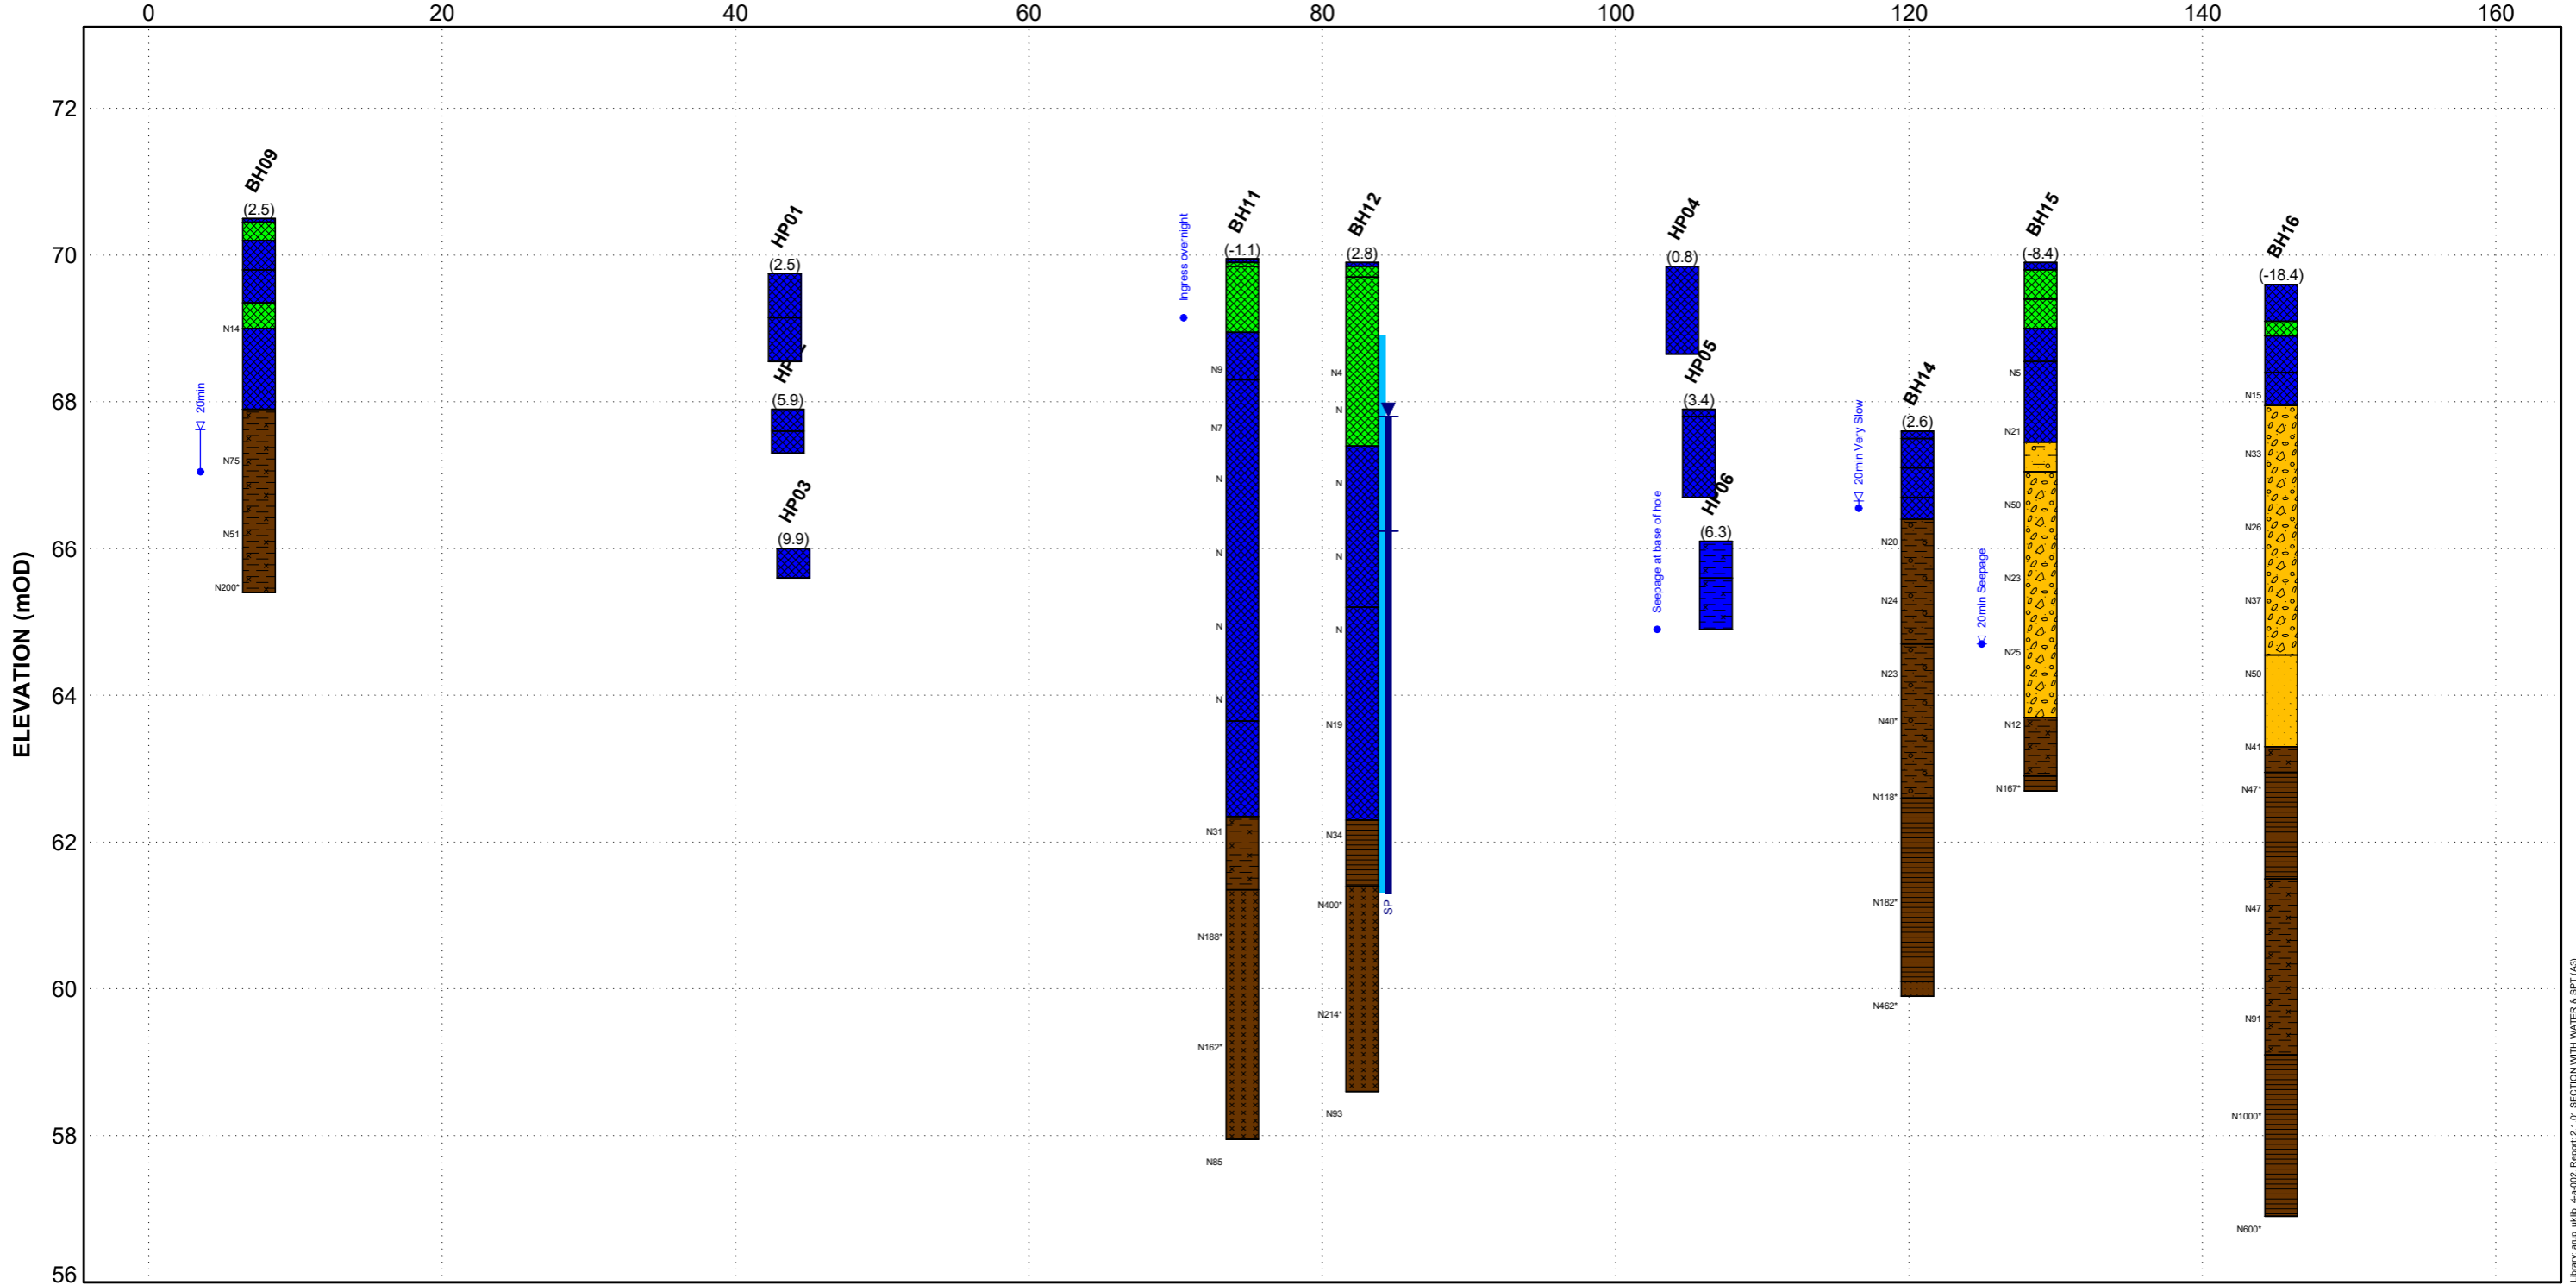
A cross section of the encountered ground conditions is presented in Appendix A Figure 2 (alignment also shown on Drawing 3). The elevation of the crest generally descends linearly by ~0.5m between BH09 (~70.5mAOD) and BH15 (~70mAOD) (chainage of ~120m).

Unlike Lower Cannop Pond, the embankment at Upper Cannop Pond does not show the distinct delineation between granular and cohesive layers of Embankment Fill. The Embankment Fill varies across the crest, with BH09, BH15, and BH16 encountering alternating layers of cohesive and granular material. BH11 and BH12 encountered granular Embankment Fill overlying cohesive Embankment fill, however, the thickness of this material varies by ~1.5m over ~8m east-west and ~4m north-south. Granular Embankment Fill at Upper Cannop Pond generally comprises clayey gravelly sand and very loose clayey sandy gravel.
