Cropton Forest Beaver Trial 2019-2024

Our 5-year trial

Cropton Forest Beaver Trial begins

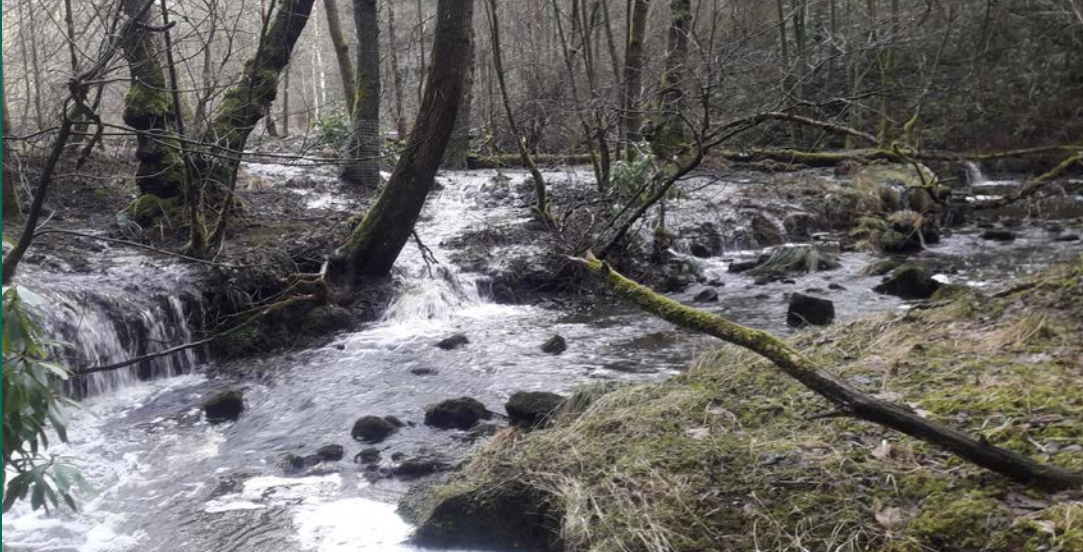
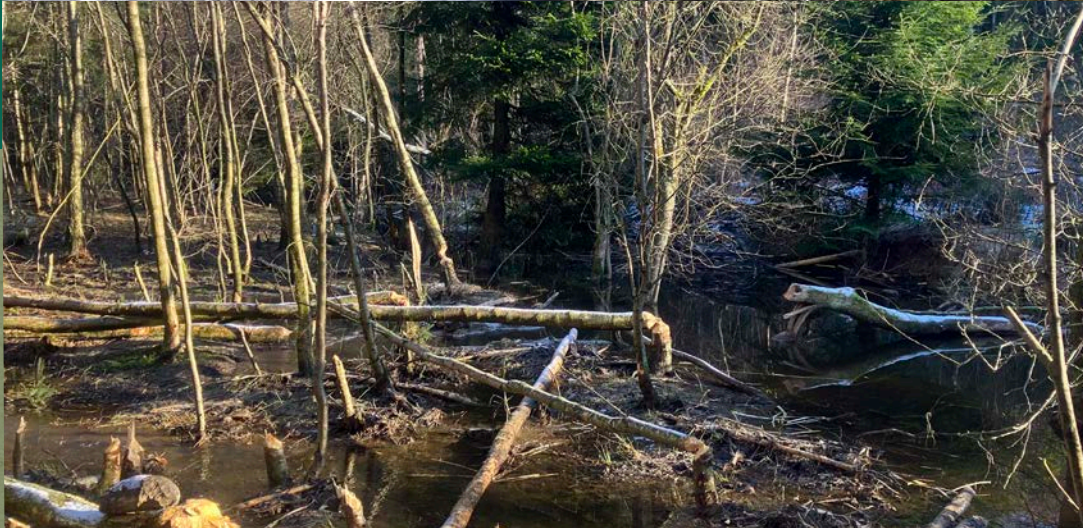
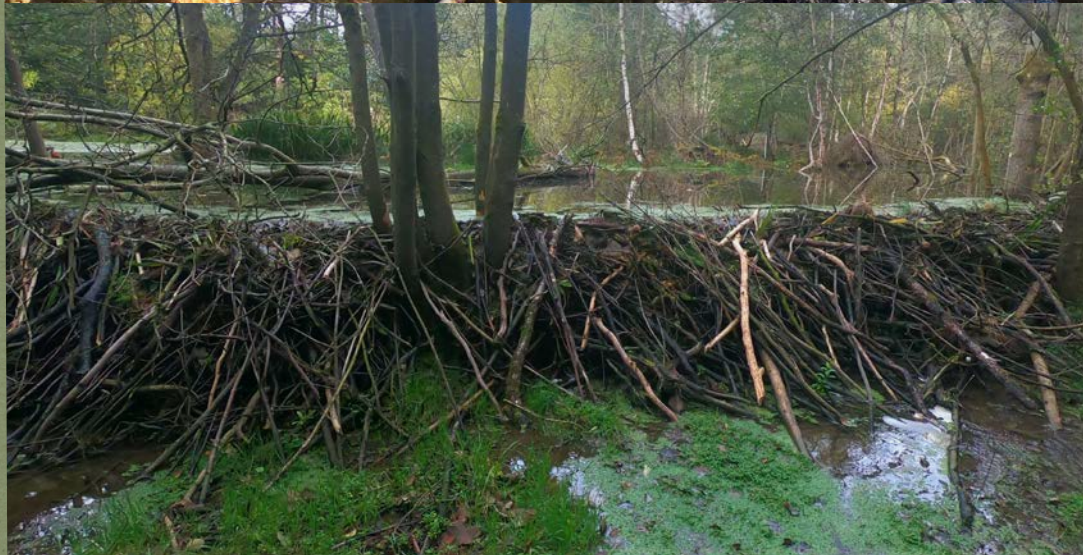
The upper pond changed a couple of times throughout the 5-year trial. The beavers initially blocked the leak in the pond with silt and horsetails; raising the water levels by about 60cm. In autumn 2022, the beavers dug a channel to drain some of the water from the top pond. This area has developed into a mosaic of water and marsh habitat with deeper channels and pools with a range of aquatic plants on its banks.

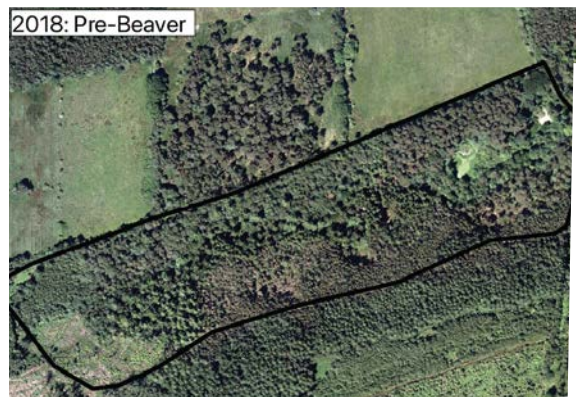
Figure 1. Beaver surface water creation at the site as visualised using a 2024 drone survey and a pre-beaver 2018 aerial image accessed via Getmapping Aerial Imagery.

Aerial drone surveys indicate the beavers have helped create an expansive and complex wetland environment within the Cropton Enclosure. Their natural landscape engineering has transformed the site. The dams created over the trial have created **extensive wetland areas with surface water covering over 5800m²**.

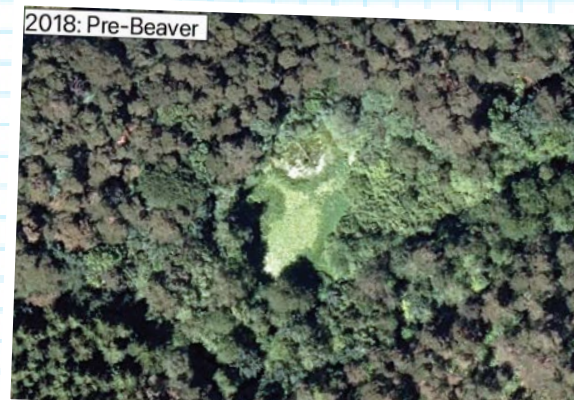
Figure 3. Beaver surface water creation at the site as visualised using a 2024 drone survey and a pre-beaver 2018 aerial image accessed via Getmapping Aerial Imagery. This shows upper half of the site and the connection between the pre-existing pond and river channel and the expansion into a combined wetland.

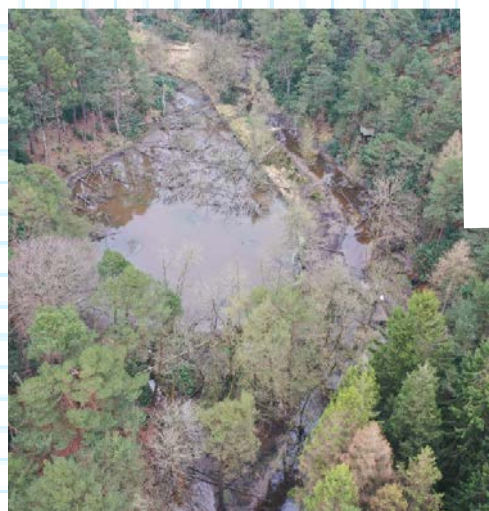
Figure 2. Aerial view of the main pond at the site, 2024.

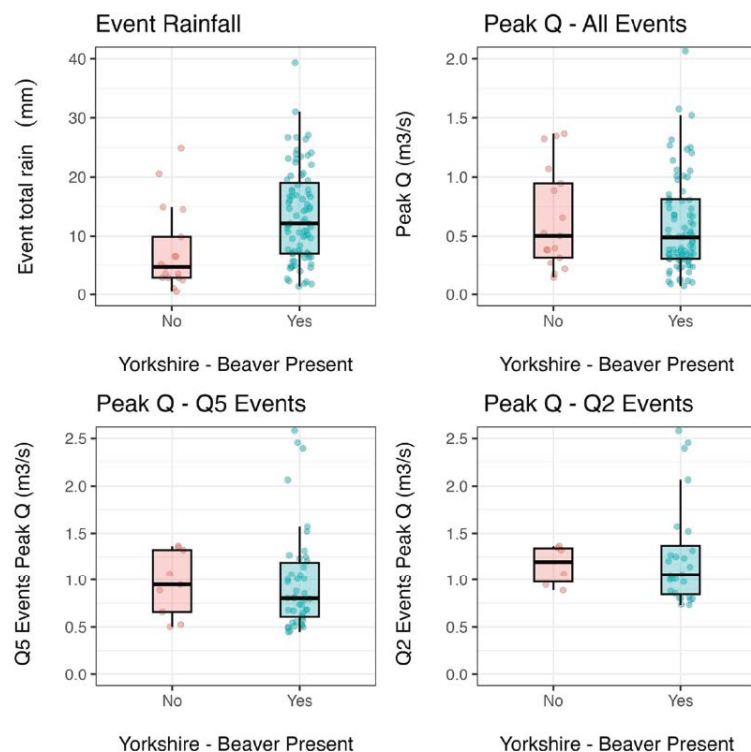
Figure 5. These boxplot diagrams demonstrate that despite an increase in the size of rainstorms experienced following beaver release, small reductions in peak discharge were observed throughout a range of event sizes.

Early results from the site have been published (Puttock et al., 2021) finding beaver dams (in combination with Slowing the Flow dams) resulted in a reduction in peak storm flows downstream. This supports other research across Britain that suggests beavers could play a vital role in natural flood mitigation and management.

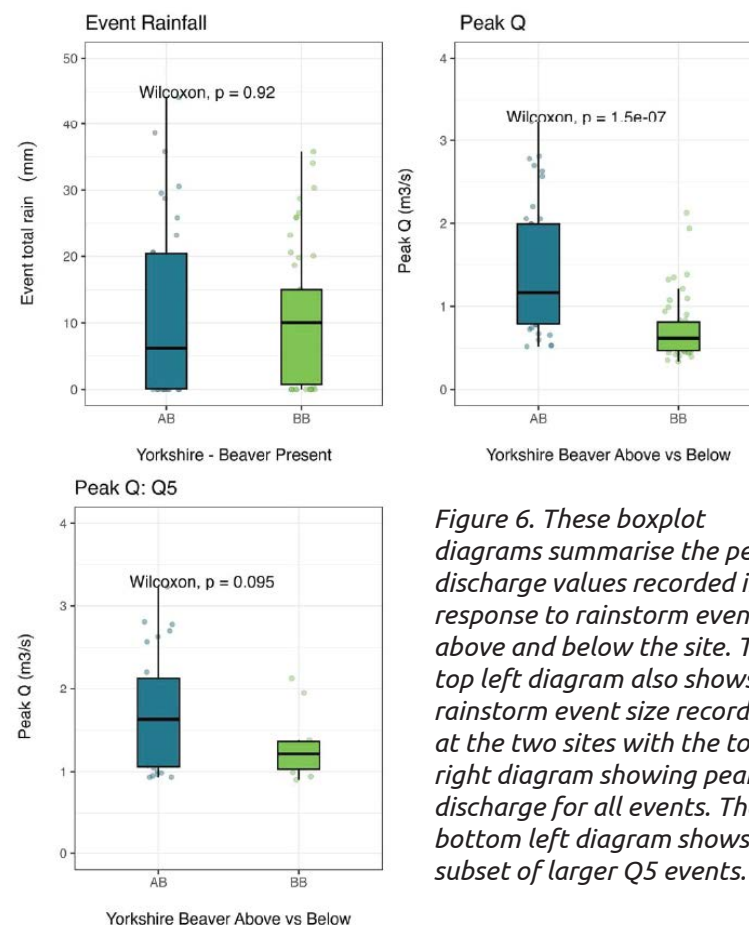
Figure 6. These boxplot diagrams summarise the peak discharge values recorded in response to rainstorm events above and below the site. The top left diagram also shows rainstorm event size recorded at the two sites with the top right diagram showing peak discharge for all events. The bottom left diagram shows the subset of larger Q5 events.

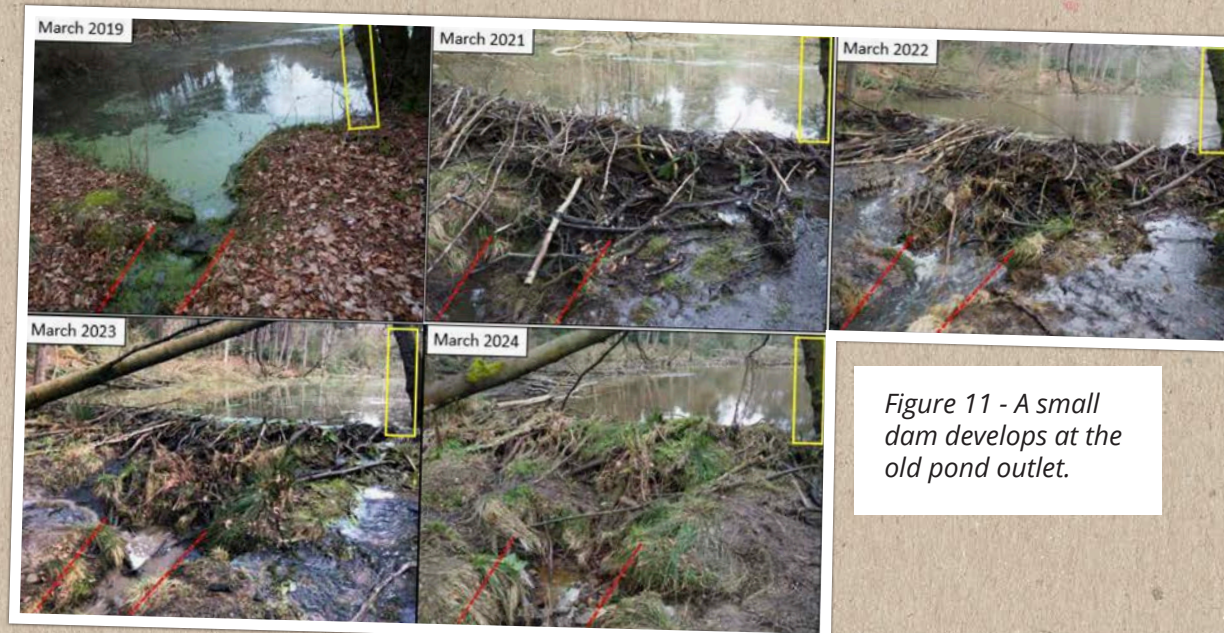
Figure 11 - A small dam develops at the old pond outlet.

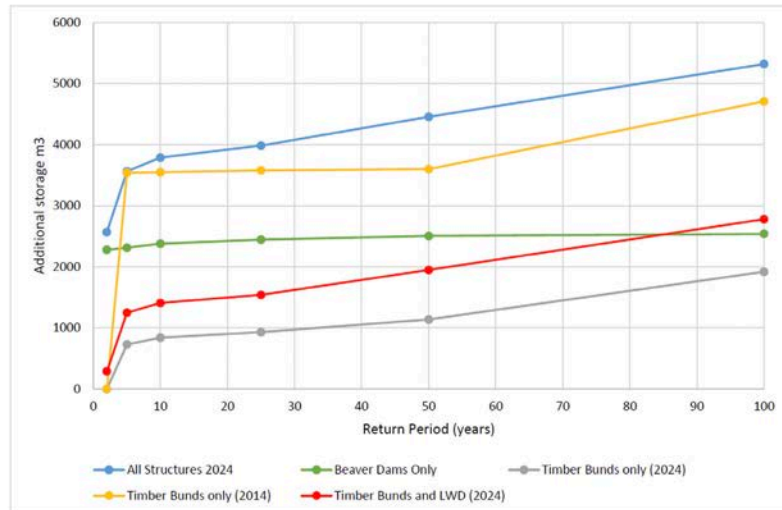
Comparison of the additional flood storage potential of man-made versus beaver-built dams

The modelling study shows that the Cropton Forest beaver dams alone make a significant contribution to the potential additional flood storage at the site. In combination, the four beaver dams provide significantly more additional storage potential than the timber bunds in their current condition. However, they fall short of providing the equivalent storage that the bunds provided when they were originally installed and designed appropriately. This difference is likely to further increase as the timber bunds continue to deteriorate and the beavers potentially build more dams.

The total volume of flood storage provided by the two timber bunds in their current condition, the three LWD and the four beaver dams exceeds that of the original timber bunds, across the range of modelled flood magnitudes (1 in 5 year to 1 in 100 year floods).

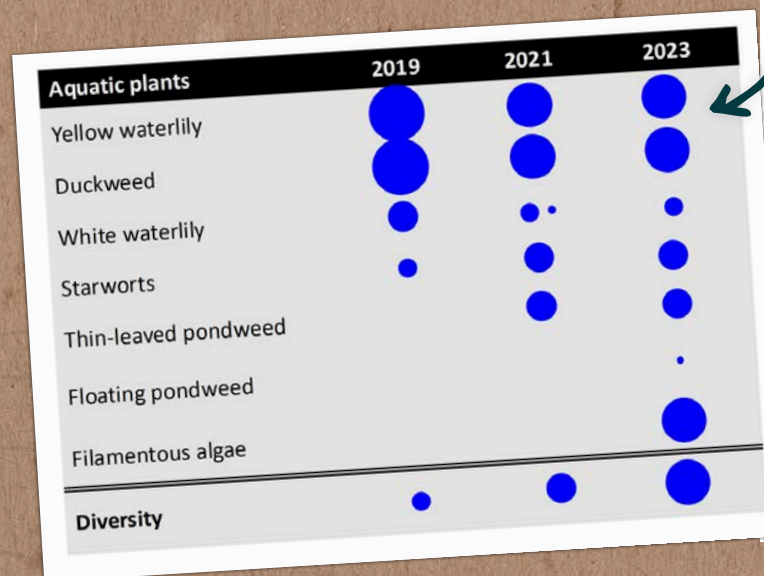
Figure 2. - The number of truly aquatic plants is steadily growing within the main beaver pond. We found new species for the site every time we surveyed, but there is another type of change to highlight, in addition to this increase in biodiversity. **Initially the waters were overwhelmed by two species**, which is an **indication of ecological imbalance**. With time not only did the pond host more species but also there is **increasingly a balance** of aquatic species living in the pond.

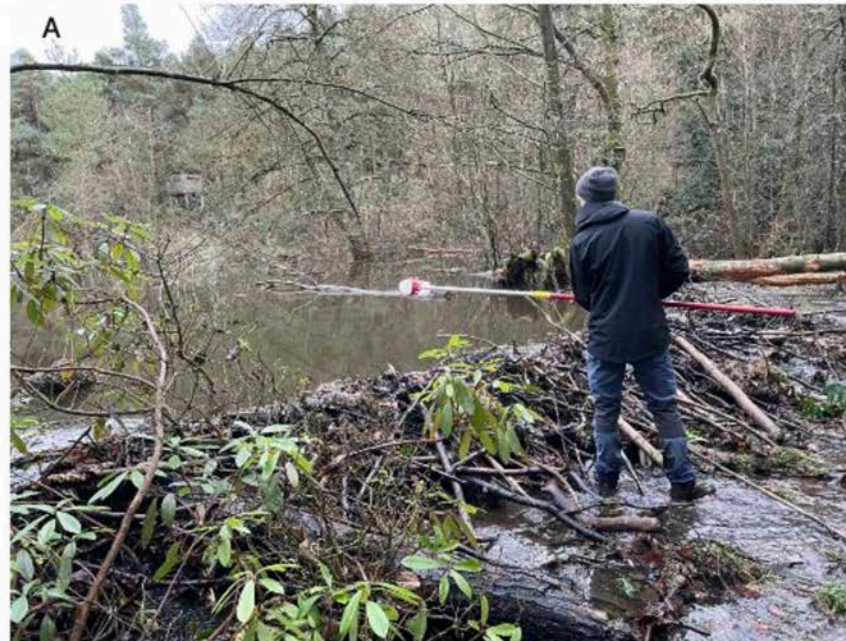
Figure 1
a) Sampling water from above the main dam. Two litres of water is collected from each sampling point for eDNA analysis.
b) Overview of eDNA workflow

Nineteen water samples were collected in May 2022: 10 within the Cropton Forest Beaver Trial enclosure and 9 at nearby Pickering Beck (Fig. 1a). Water samples were filtered to capture eDNA, and DNA extracted and sequenced, targeting vertebrates only. DNA sequences were matched to a reference database, to assign them taxonomically (Figure 1b).
